Wind and Seismic Effects

Proceedings of the 32nd Joint Meeting

NIST Special Publication 963

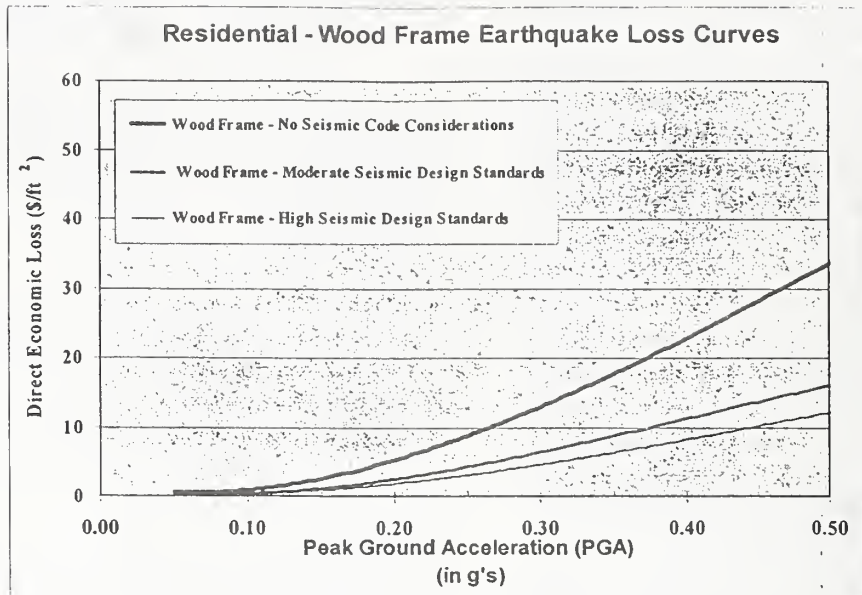
Figure 1 Potential damage to wood frame single-family residence from various levels of ground shaking intensity for three levels of seismic design. The damage is quantified in terms of the economic loss (\$/ft²) and includes the cost to repair the damaged home, the cost to replace damaged contents and any additional temporary living expenses caused by the earthquake.

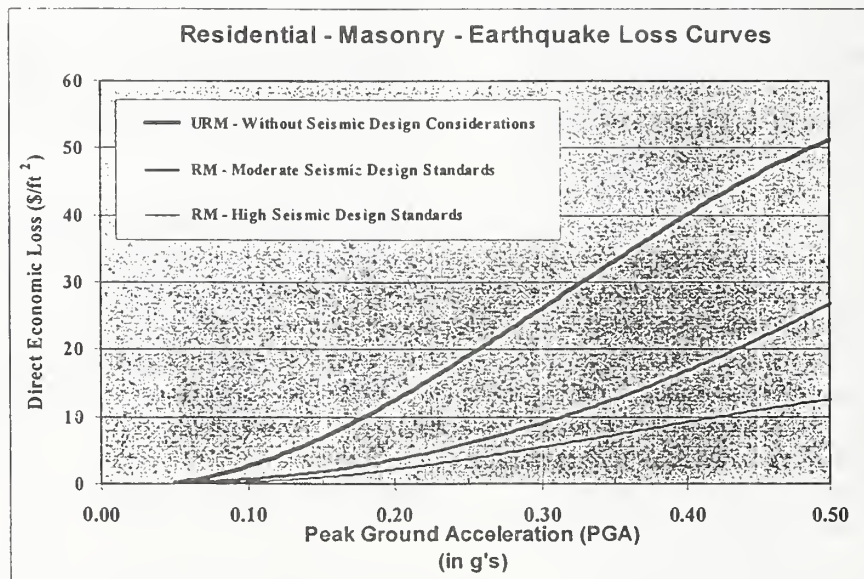
Figure 2. Potential damage to a masonry single-family residence from various levels of ground shaking intensity for three levels of seismic design. The damage is quantified in terms of the economic loss (\$/ft²) and includes the cost to repair the damaged home, the cost to replace damaged contents and any additional temporary living expenses caused by the earthquake.

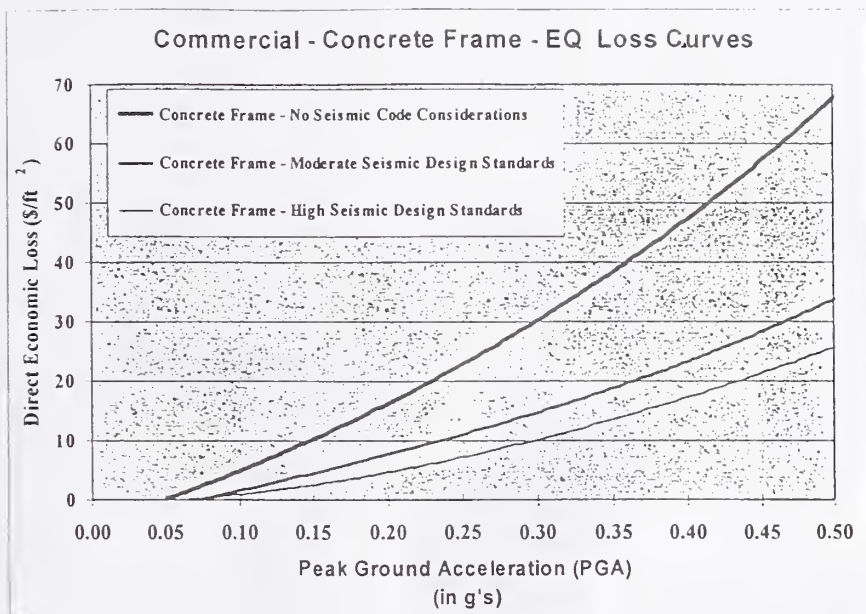
Figure 3. Potential damage to concrete frame office building from various levels of ground shaking intensity for three levels of seismic design. The damage is quantified in terms of the economic loss (\$/ft²) and includes the cost to repair the damaged structure, the cost to replace damaged contents and any additional business interruption expenses caused by the earthquake.

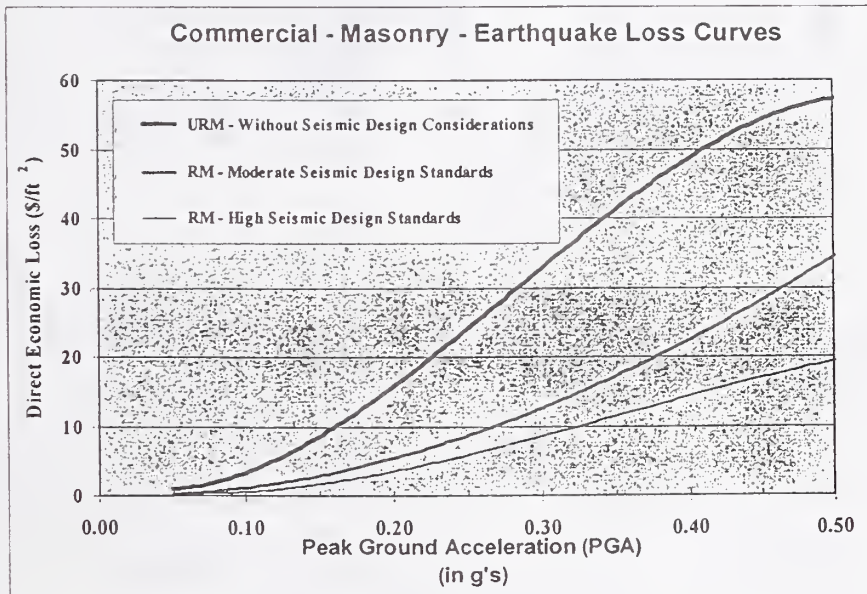
Figure 4. Potential damage to a commercial, low-rise masonry office building from various levels of ground shaking intensity for three levels of seismic design. The damage is quantified in terms of the economic loss (\$/ft²) and includes the cost to repair the damaged structure, the cost to replace damaged contents and any additional business interruption expenses caused by the earthquake.

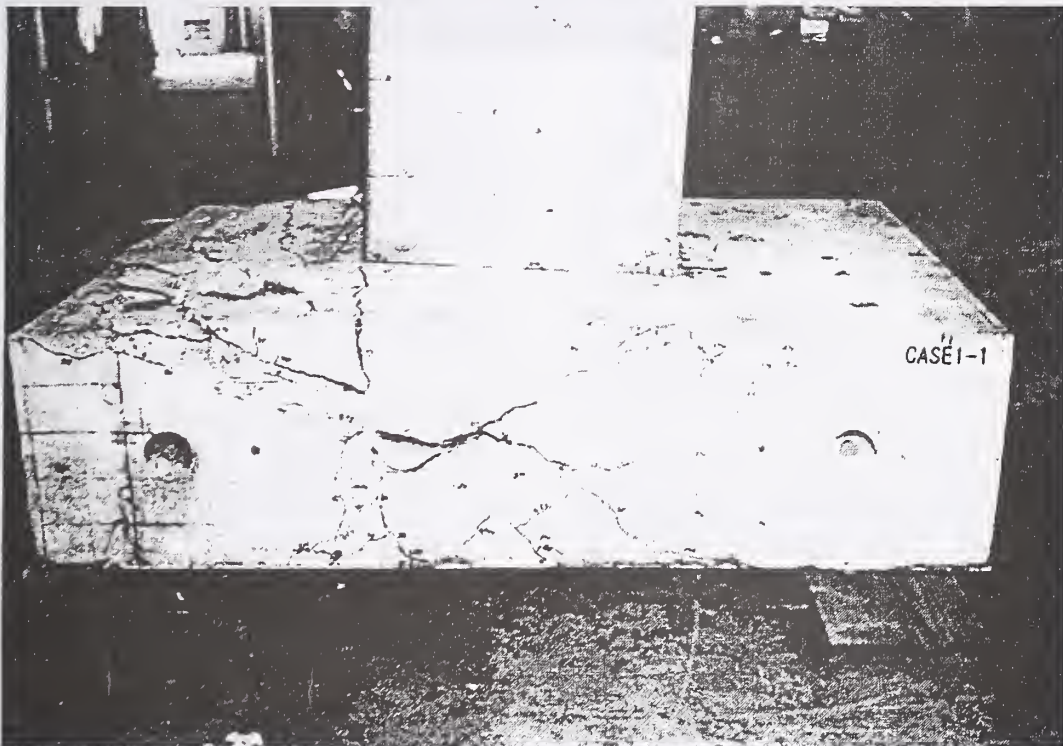
Photograph 1 State of the Failure (Case 1-1)

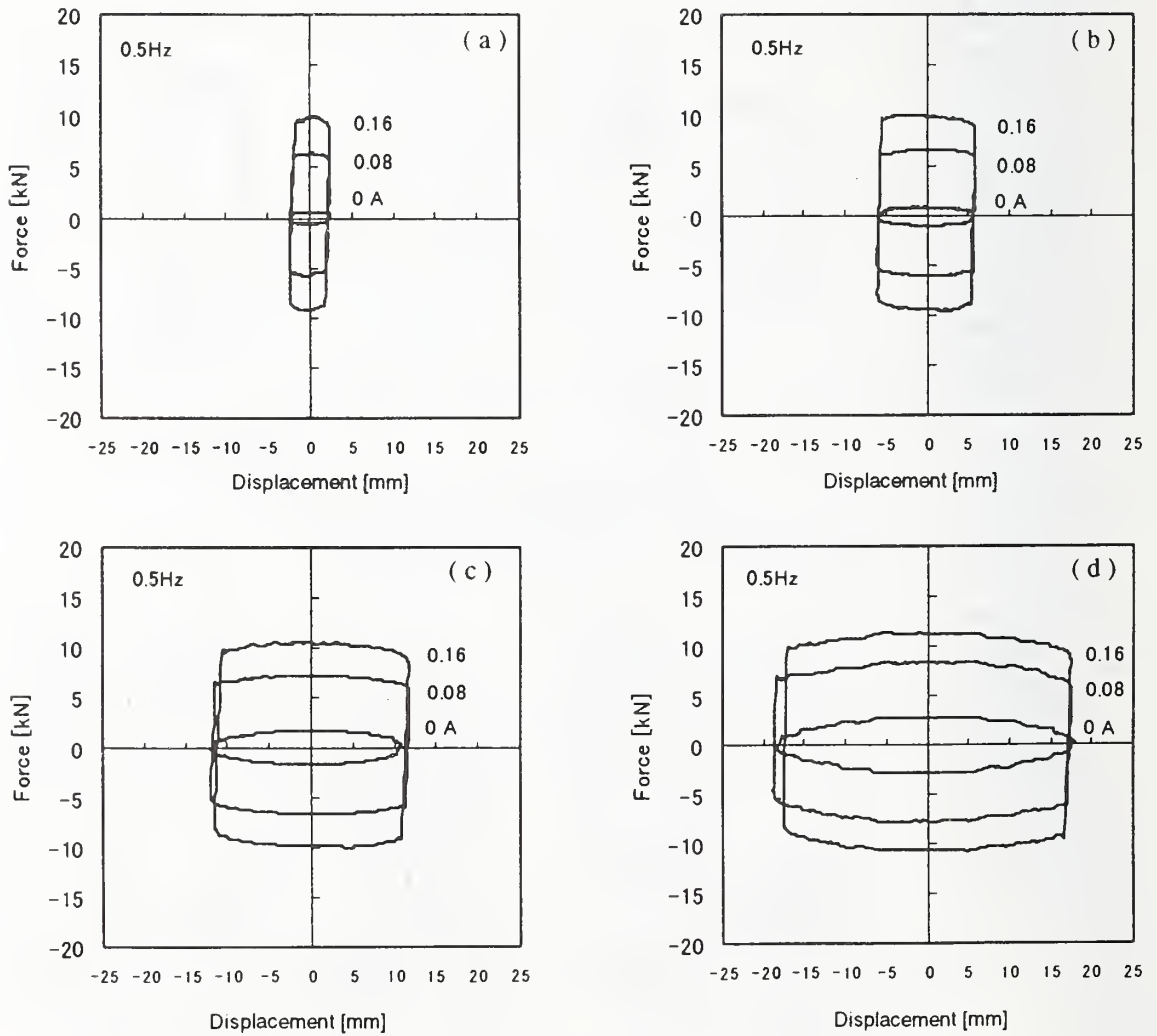
Figure 7 Force-displacement Loops for 20kN MRF Damper

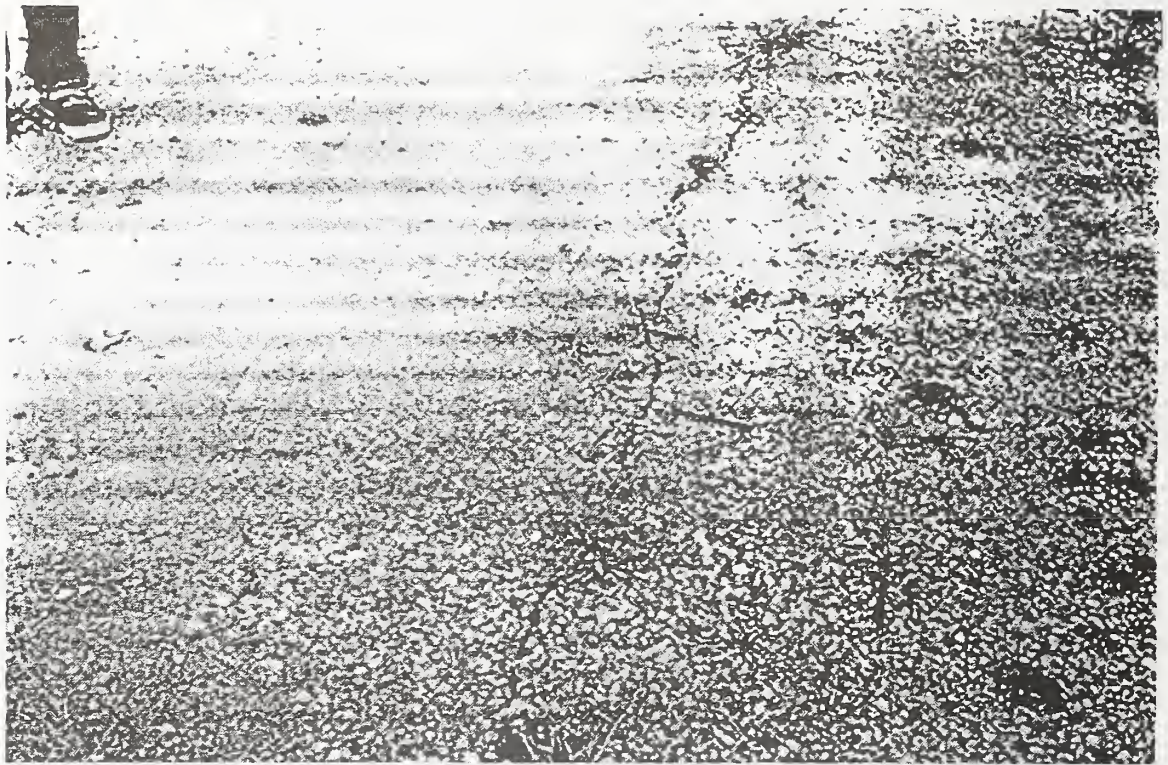
Figure 3. Longitudinal crack near the edge of the crest of Gokce Dam on the upstream side. The location is about at the middle of the dam. The width of the crack was about 7 mm at its greatest

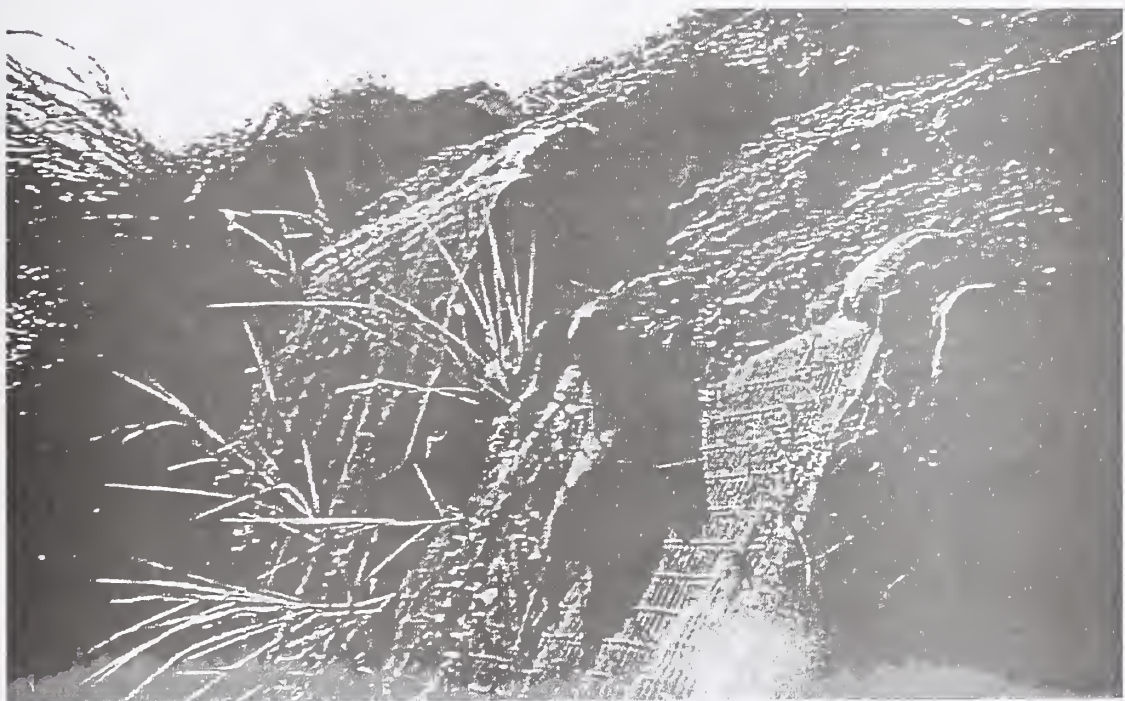
Photo.3 Failure of the reinforcement
